STORMWATER CONTROL PLAN

Grading and Paving Parcel 566500 0256

City of Buckley
Parcel Number 566500 0256
278XX SR 410E

PSED PLAT & SITE CIVIL DESIGN, LLC

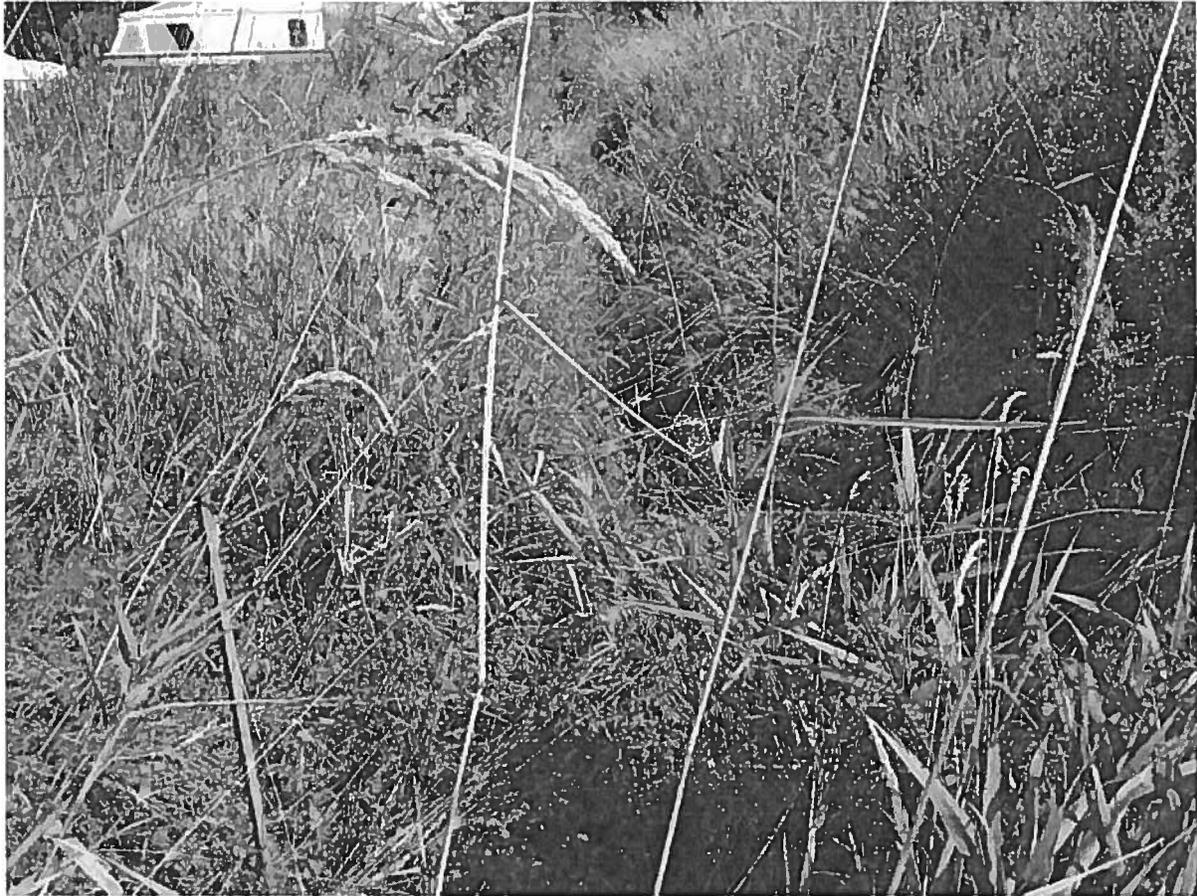
At the northwest corner looking north into the ditch/swale that drains away.

1. Runoff off the northwest corner is to be routed through a new ditch to be constructed on the north side of the existing detention pond on the adjacent parcel.
2. Runoff then flows north into a ditch between parcels running north to Hinkleman Road. Approximately 90 ft north of the site, this ditch becomes undefined, with the west side and bottom levelling off to flush with the adjacent ground.
3. This ditch then empties into a road ditch adjacent to Hinkleman, running west from there to east ditch adjacent to Mundy Loss Road.
4. This ditch runs north on the east side of Mundy Loss, crossing several driveways in culverts, until reaching the 1/4 mile point.

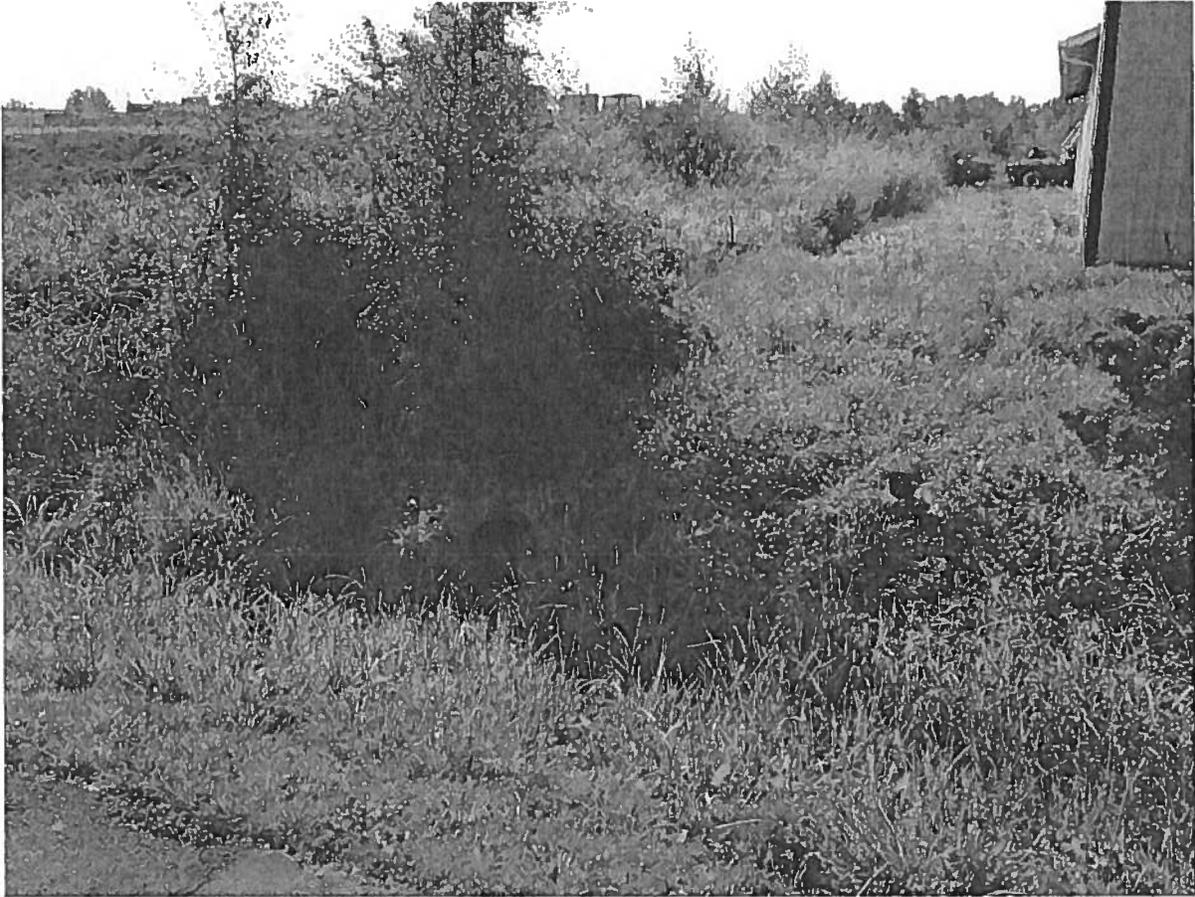
From Hinkleman Rd looking south back at the ditch/swale approaching the roadditch. Off in the distance, beyond the blue car, the ditch becomes undefined, with the bottom and west bank becoming flush with the ground adjacent.

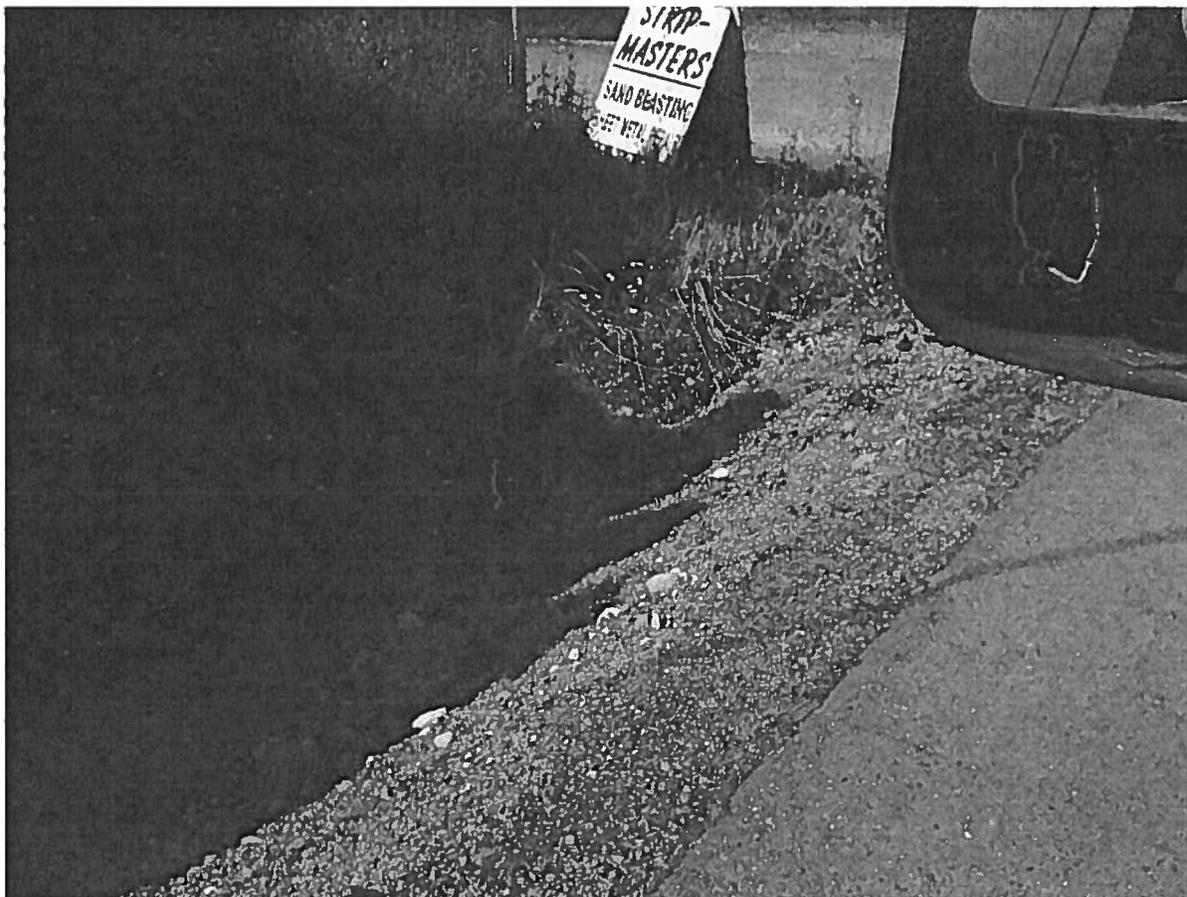
The roadditch on Hinkleman flowing westerly.

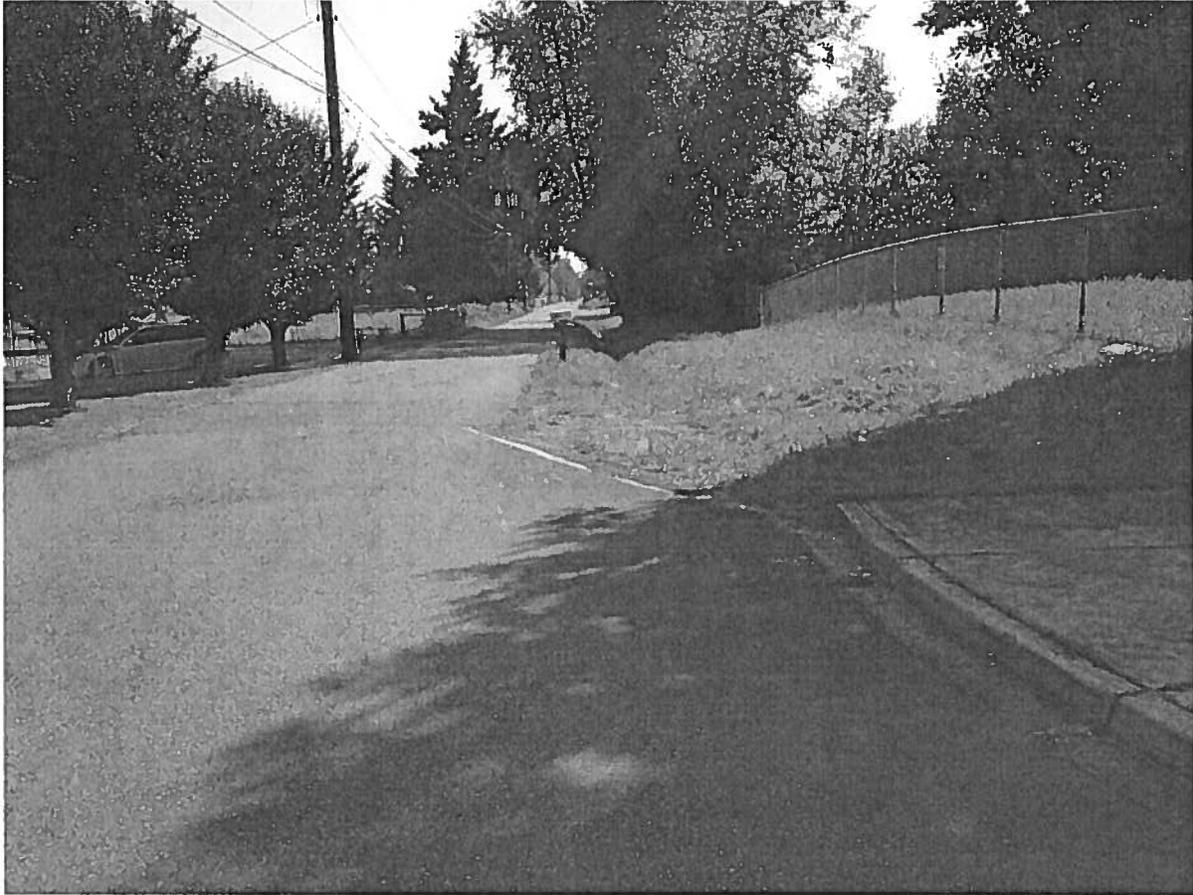
At the intersection of Hinkleman and Mundy Loss looking back to the east to the approaching road ditch. A crossing exists under the intersection, releasing water to the roadditch on the east side of Mundy Loss, flowing north.

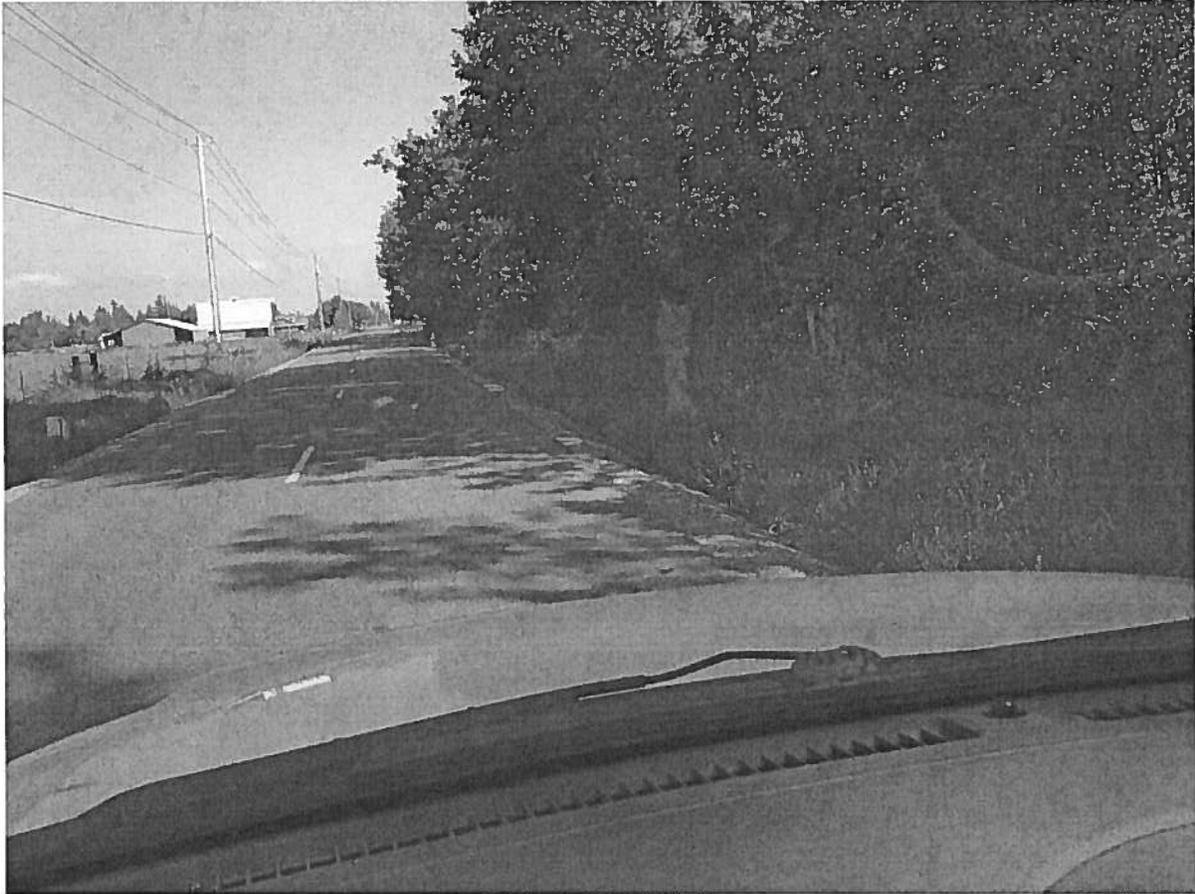
North on Mundy Loss, 1/4 mile from site

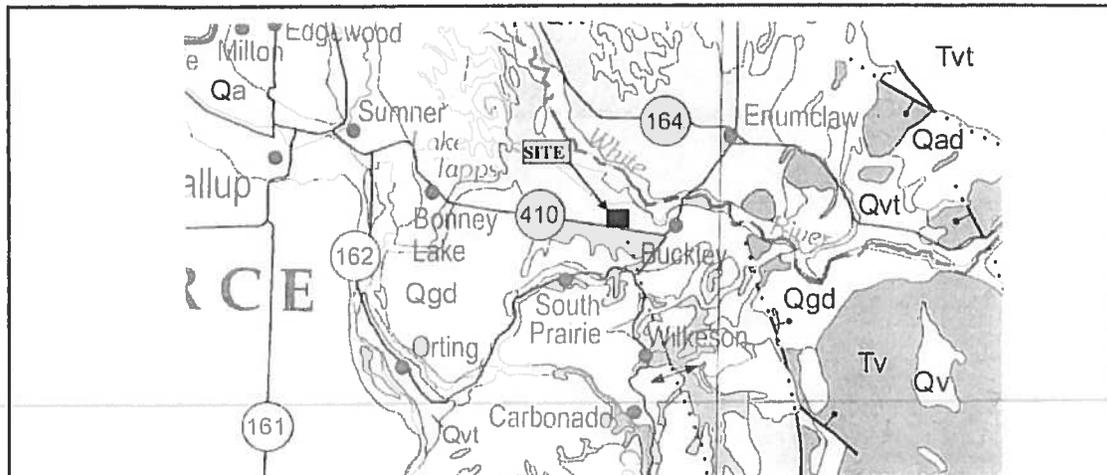
Project No.: 14-445	PROJECT Genisls Property 27971, SR 410 E Hwy Buckley, Pierce County, WA	PGE Pacific Geo Engineering <small>Geotechnical Engineering, Consulting & Inspection</small>
Date: November 30, 2014		
Drawn By:		
Client: W. S. Contractors		Figure 4

Source - WA State Dept. Natural Resources
 Geologic Map of WA State By J. Eric Schuster, 2005
 Qvt - Quaternary fragmental volcanic deposit includes lahars

GEOLOGICAL UNIT MAP
 Not to Scale

As per the WA State Department of Natural Resources' Geologic Map of WA State by J. Eric Schuster, 2005, the subject site is underlain by the geologic unit 'Qvt', which is described as the '*Quaternary fragmental volcanic deposits that includes the lahars*'. A 'lahar' is a debris avalanche that originates from the flanks of a volcano (the Indonesian word for a mudflow). The geologic map is attached in Geological Unit Map, Figure 4.
